Kansas Department of Corrections
El Dorado Correctional Facility Oswego
June 2022

ASSESSMENT OVERVIEW

El Dorado Correctional Facility Oswego

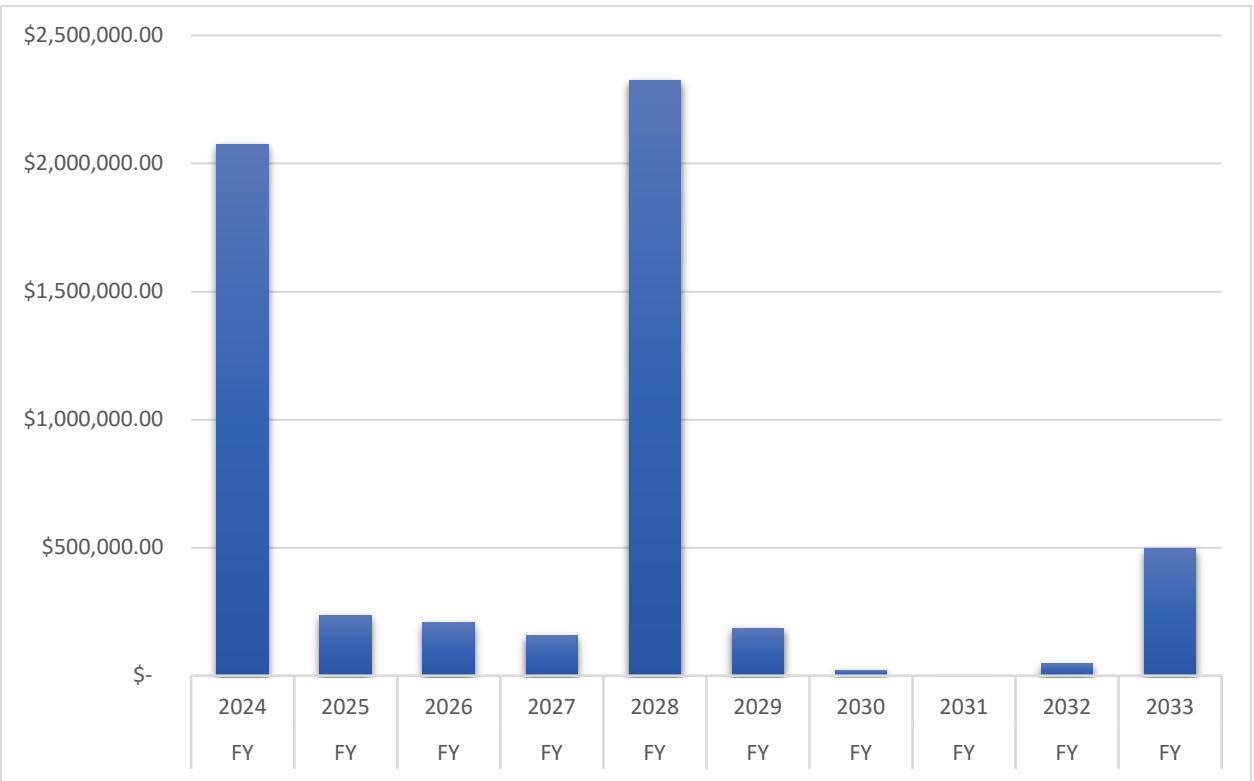
The building expenditure summary section provides an executive overview of the findings from the assessment. The chart below provides a summary of anticipated yearly expenditures over the study period for the El Dorado Correctional Facility - Oswego. Further details of these expenditures are included within each respective report section and within the expenditure forecast in Appendix A of this report. The results illustrate a total anticipated expenditure over the study period of approximately: \$5,748,267

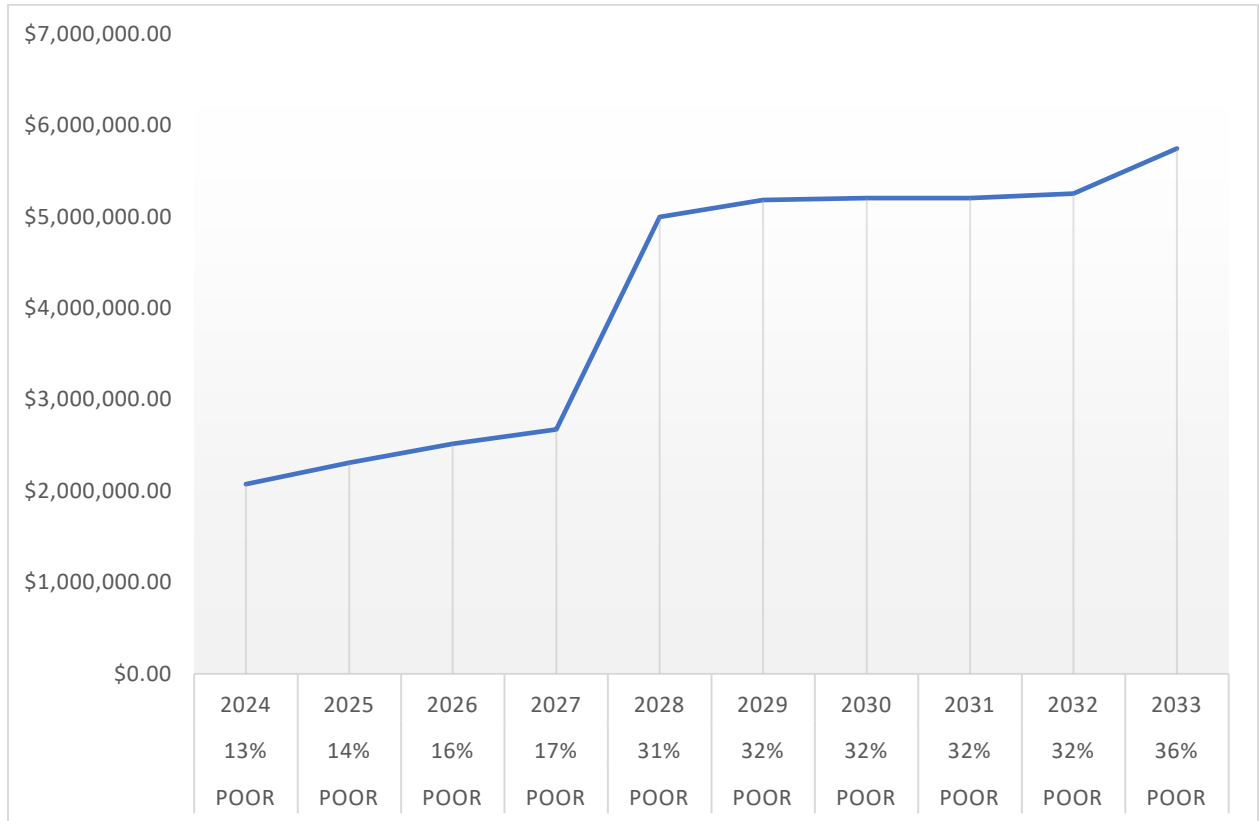
FACILITY CONDITION NEEDS INDEX

In this report, we have calculated the Facility Condition Needs Index (FCNI), which is used in Facilities Management to provide a benchmark to compare the relative condition of a group of facilities. The FCNI is primarily used to support asset management initiatives of federal, state, and local government facilities organizations.

The FCNI is the ratio of accumulated Total Cost (TC) (Deferred Maintenance, Capital Renewal, and Plant Adaptation) to the Current Replacement Value (CRV) for a constructed asset calculated by dividing the TC by the CRV. The range is from zero for a newly built asset to one for a constructed asset with a TC value equal to its CRV. Acceptable ranges vary by "Asset Type", but as a general guideline, the FCNI scoring system is as follows:

$$\text{FCNI} = \frac{\text{Deferred Maintenance} + \text{Capital Renewal} + \text{Plant Adaptation (TC)}}{\text{Current Replacement Value of the Facility(s) (CRV)}}$$

If the FCNI rating is 60% or greater, then the replacement of the asset/building should be considered instead of renewal.

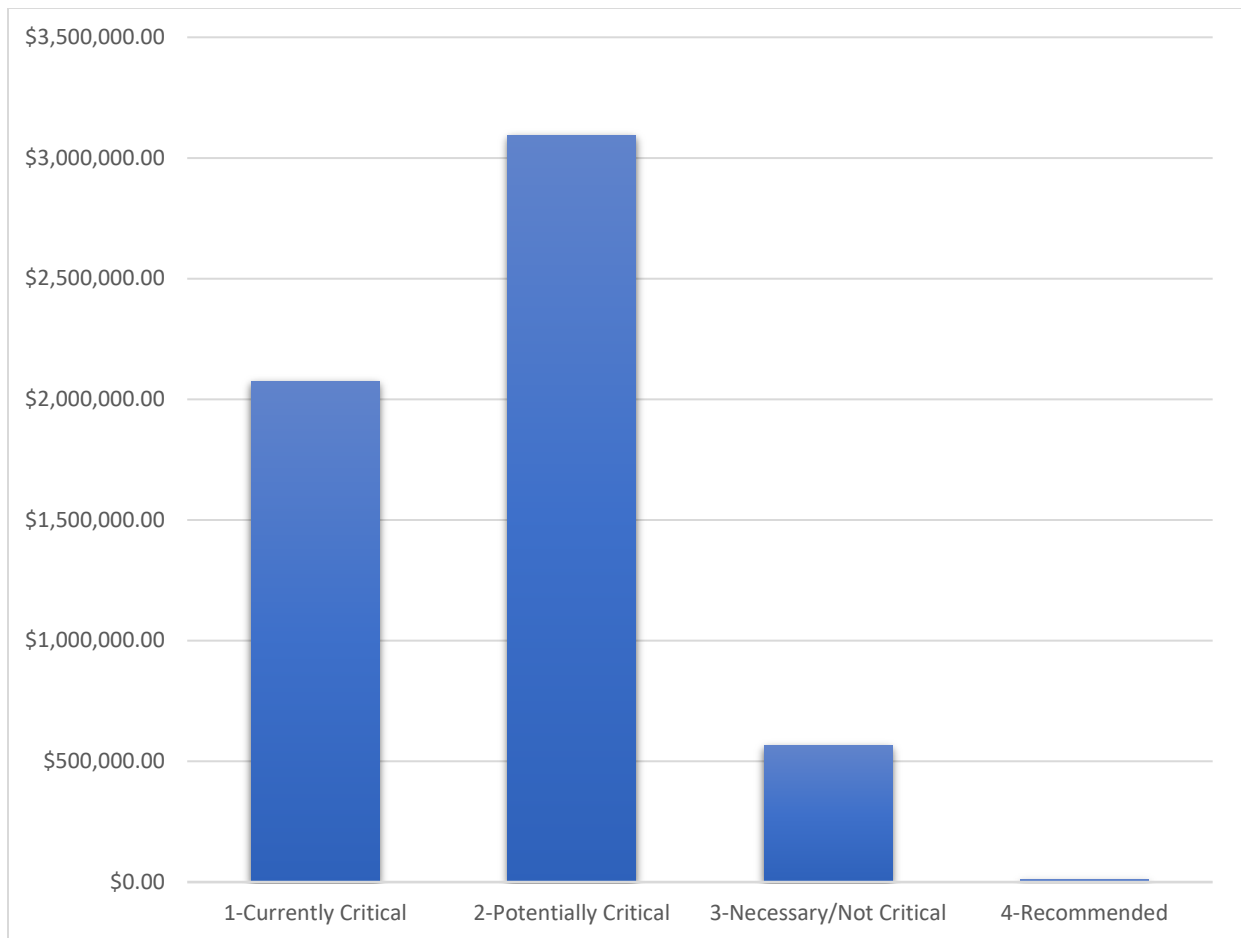
DISTRIBUTION OF NEEDS BY PRIORITY

CGL Facility Management has prioritized the identified work in order to assist with analyzing the deficiencies found during the assessment. The baseline prioritization model is not just based on replacement year or criticality but uses four key data attributes to build an overall importance metric for every recommendation: System type, the cause or nature of the issue, timing, and building mission incorporated into the model with relative weighting to provide an overall priority score. Priority categories are shown below:

Priority 1 Currently Critical:	Systems requiring immediate action that have failed, compromises staff or public safety, or required to be upgraded to comply with current codes and accessibility
Priority 2 Potentially Critical:	A system or component is nearing the end of useful life, if not addressed, will cause additional deterioration and added repair costs
Priority 3 Necessary / Not Critical:	Lifecycle replacements necessary but not critical or mid-term future replacements to maintain the integrity of the facility or component
Priority 4 Recommended:	Items under this classification are not required for normal function and operation of the facility but would improve the efficiency and functionality of the facility or reduce long-term maintenance.

The chart below illustrates the breakdown of expenditure according to the priority coding providing an opportunity to strategically plan and effectively direct funding to the highest priority.

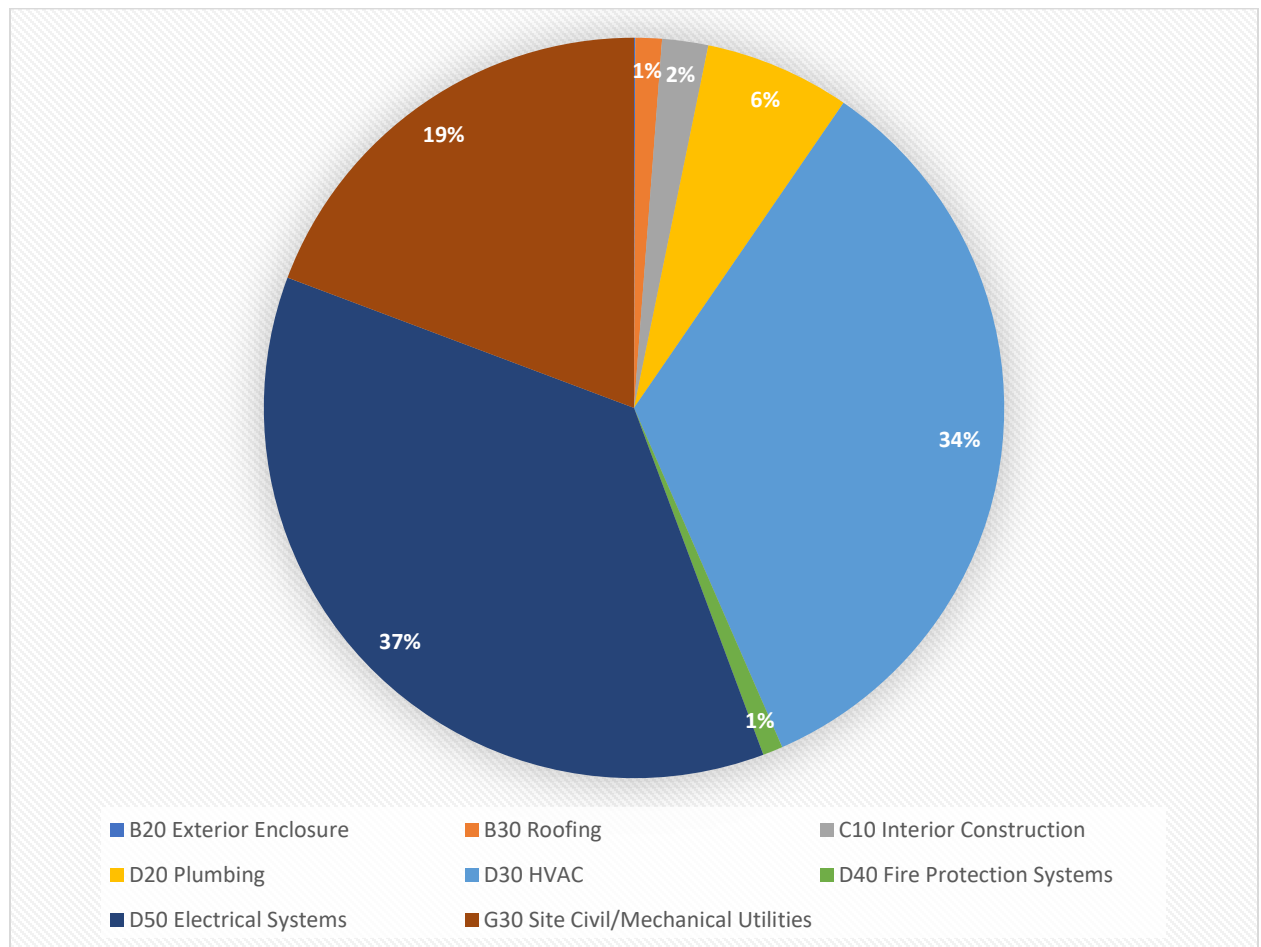
DISTRIBUTION OF IMMEDIATE NEEDS (YEAR 1) BY BUILDING SYSTEM

Building System	Estimated Cost	Percent of Total Cost
B20 Exterior Enclosure	\$1,154	0.06%
B30 Roofing	\$23,998	1.16%
C10 Interior Construction	\$41,692	2.01%
D20 Plumbing	\$131,952	6.36%
D30 HVAC	\$702,865	33.87%
D40 Fire Protection Systems	\$18,161	0.88%
D50 Electrical Systems	\$755,564	36.40%
G30 Site Civil/Mechanical Utilities	\$400,063	19.28%

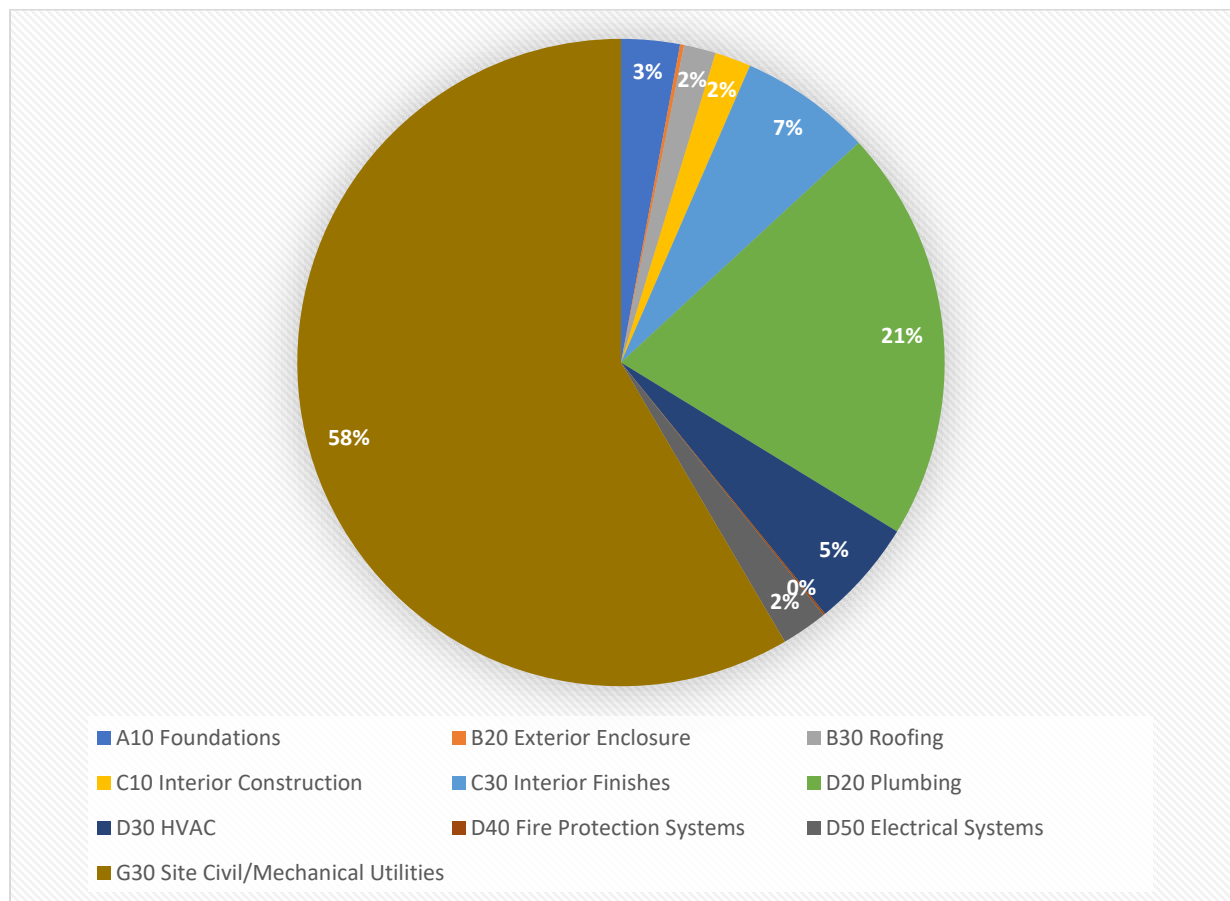
DISTRIBUTION OF FUTURE NEEDS (YEAR 2 TO YEAR 10) BY BUILDING SYSTEM

Building System	Estimated Cost	Percent of Total Cost
A10 Foundations	\$107,464.00	2.93%
B20 Exterior Enclosure	\$7,337.06	0.20%
B30 Roofing	\$58,604.74	1.60%
C10 Interior Construction	\$66,313.52	1.81%
C30 Interior Finishes	\$242,316.52	6.60%
D20 Plumbing	\$757,129.84	20.61%
D30 HVAC	\$198,534.62	5.41%
D40 Fire Protection Systems	\$3,474.90	0.09%
D50 Electrical Systems	\$84,993.12	2.31%
G30 Site Civil/Mechanical Utilities	\$2,146,652.20	58.45%

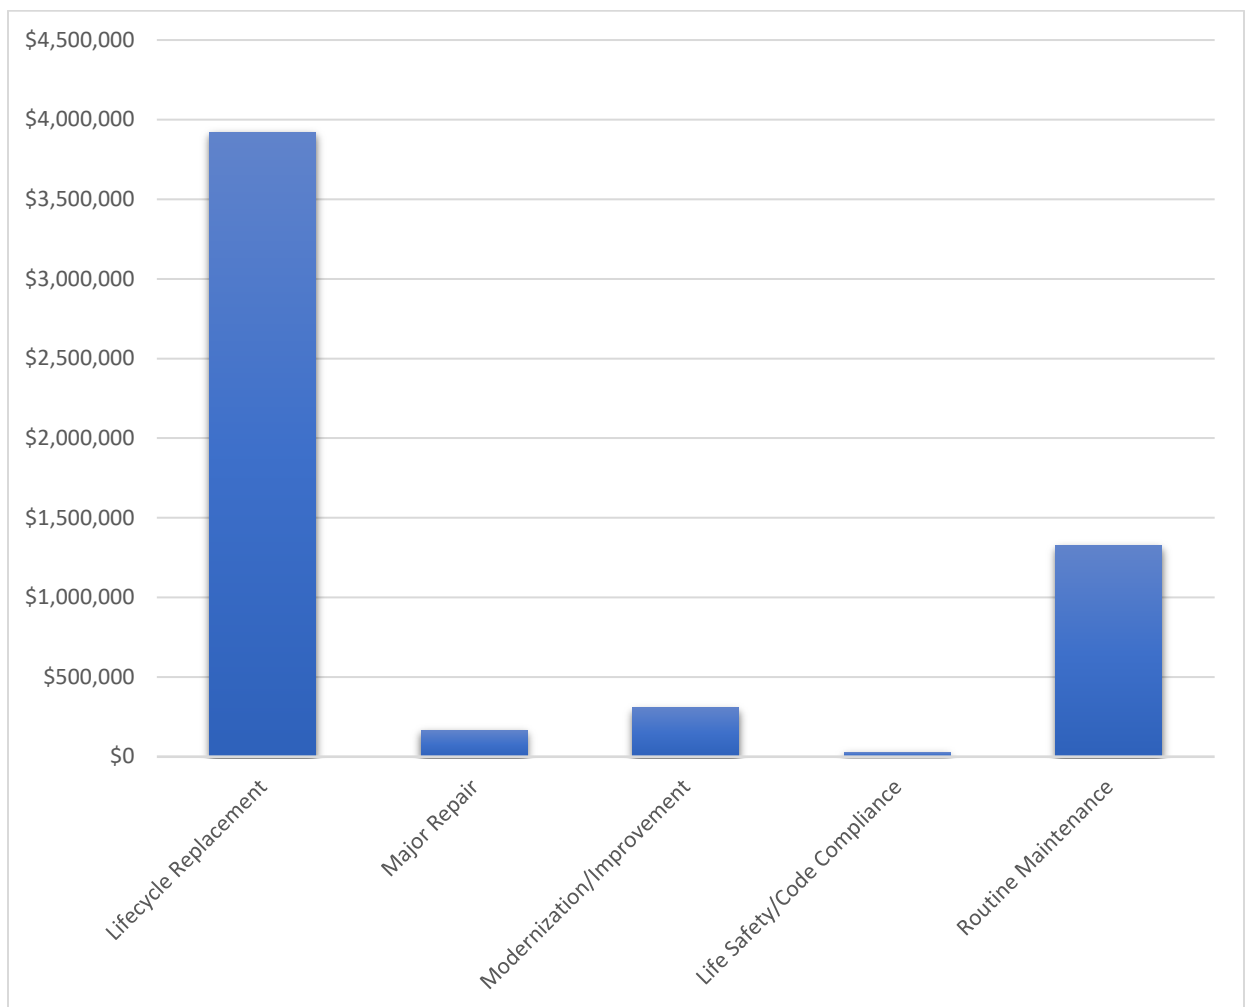
DISTRIBUTION OF NEEDS BY PLAN TYPE

PLAN TYPE	TOTAL COST
Lifecycle Replacement	\$3,920,113
Major Repair	\$166,069
Modernization/Improvement	\$307,666
Life Safety/Code Compliance	\$28,729
Routine Maintenance	\$1,325,691
