Kansas Department of Corrections  
Larned Correctional Mental Health Facility  
June 2022

## ASSESSMENT OVERVIEW

Larned Correctional Mental Health Facility

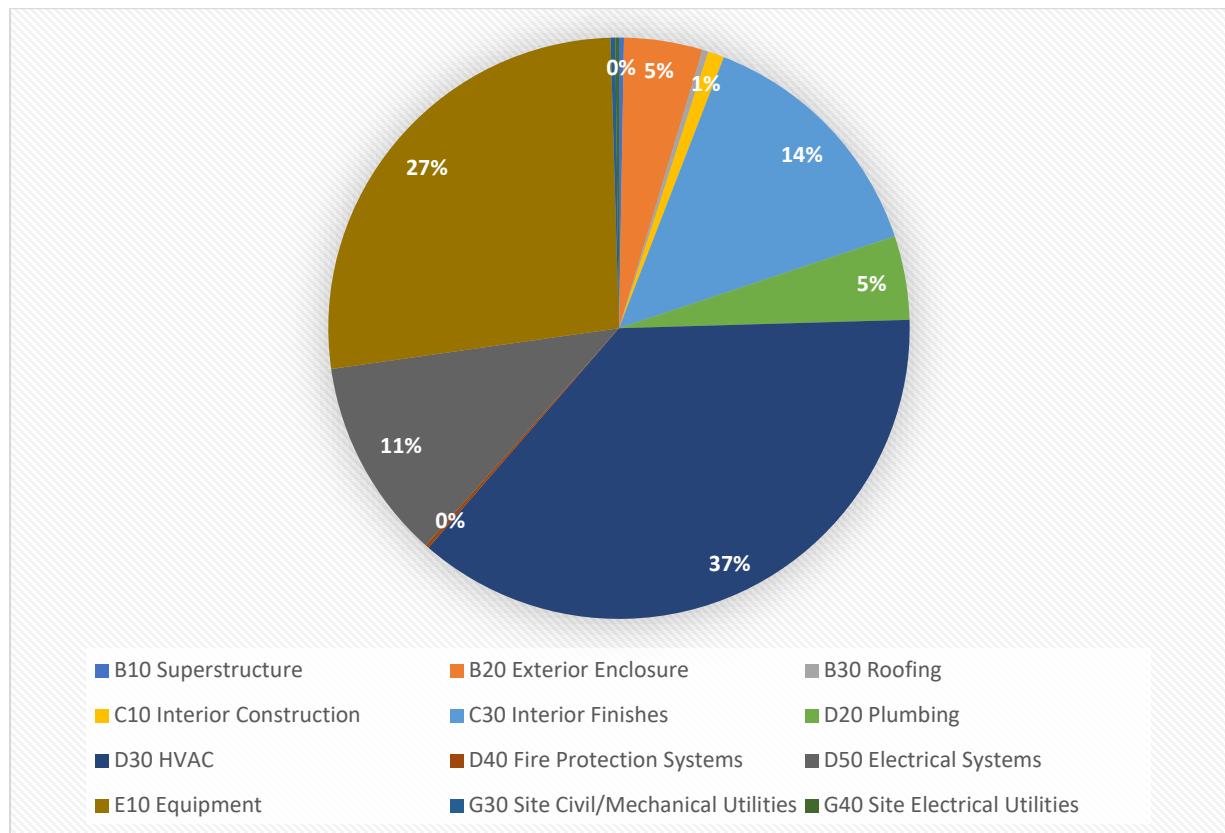
## DISTRIBUTION OF FUTURE NEEDS (YEAR 2 TO YEAR 10) BY BUILDING SYSTEM

Building System	Estimated Cost	Percent of Total Cost
B10 Superstructure	\$21,018.60	0.27%
B20 Exterior Enclosure	\$334,372.26	4.37%
B30 Roofing	\$25,581.02	0.33%
C10 Interior Construction	\$69,109.20	0.90%
C30 Interior Finishes	\$1,072,177.28	14.00%
D20 Plumbing	\$356,992.22	4.66%
D30 HVAC	\$2,821,564.94	36.84%
D40 Fire Protection Systems	\$15,243.28	0.20%
D50 Electrical Systems	\$856,134.52	11.18%
E10 Equipment	\$2,050,475.90	26.77%
G30 Site Civil/Mechanical Utilities	\$20,000.00	0.26%
G40 Site Electrical Utilities	\$15,664.00	0.20%
