Kansas Department of Corrections
Norton Correctional Facility East
June 2022

ASSESSMENT OVERVIEW

Norton Correctional Facility East

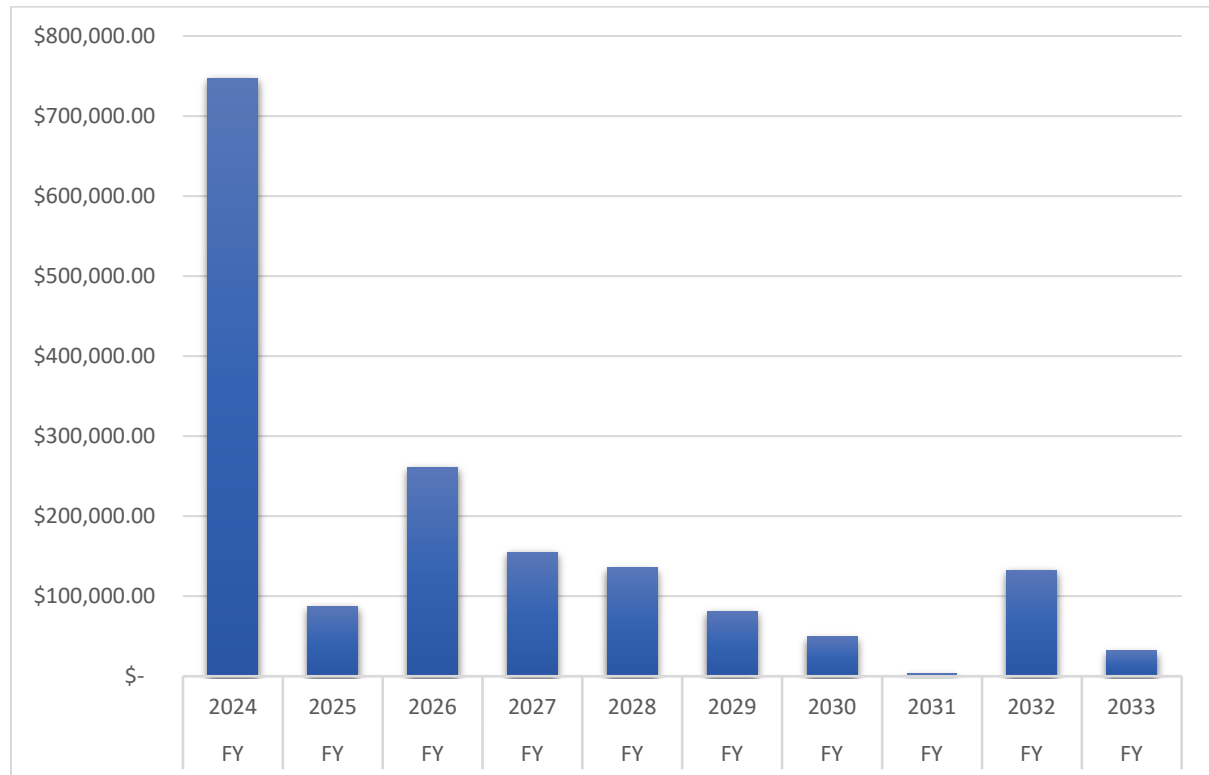
The building expenditure summary section provides an executive overview of the findings from the assessment. The chart below provides a summary of anticipated yearly expenditures over the study period for the Norton Correctional Facility East. Further details of these expenditures are included within each respective report section and within the expenditure forecast in Appendix A of this report. The results illustrate a total anticipated expenditure over the study period of approximately:

\$1,685,103

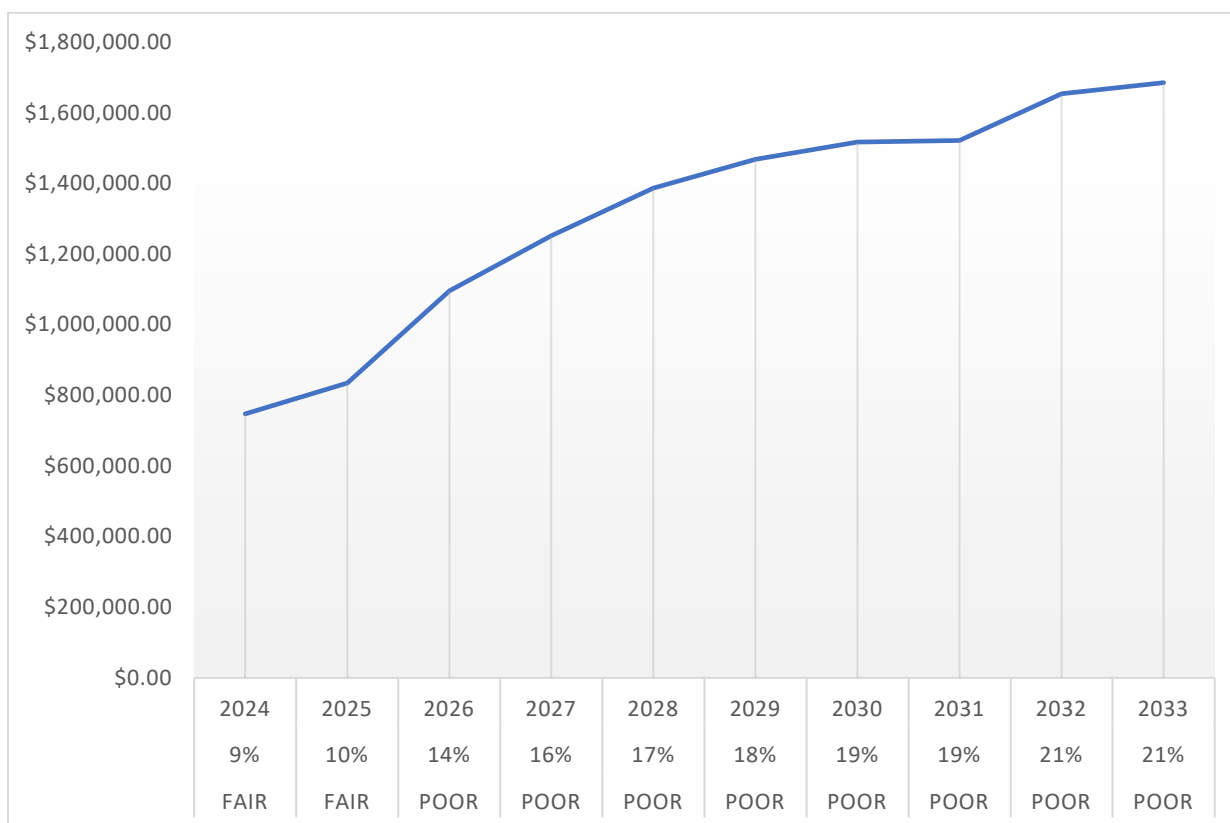
FACILITY CONDITION NEEDS INDEX

In this report, we have calculated the Facility Condition Needs Index (FCNI), which is used in Facilities Management to provide a benchmark to compare the relative condition of a group of facilities. The FCNI is primarily used to support asset management initiatives of federal, state, and local government facilities organizations.

The FCNI is the ratio of accumulated Total Cost (TC) (Deferred Maintenance, Capital Renewal, and Plant Adaptation) to the Current Replacement Value (CRV) for a constructed asset calculated by dividing the TC by the CRV. The range is from zero for a newly built asset to one for a constructed asset with a TC value equal to its CRV. Acceptable ranges vary by "Asset Type", but as a general guideline, the FCNI scoring system is as follows:

$$\text{FCNI} = \frac{\text{Deferred Maintenance} + \text{Capital Renewal} + \text{Plant Adaptation (TC)}}{\text{Current Replacement Value of the Facility(s) (CRV)}}$$

If the FCNI rating is 60% or greater, then the replacement of the asset/building should be considered instead of renewal.

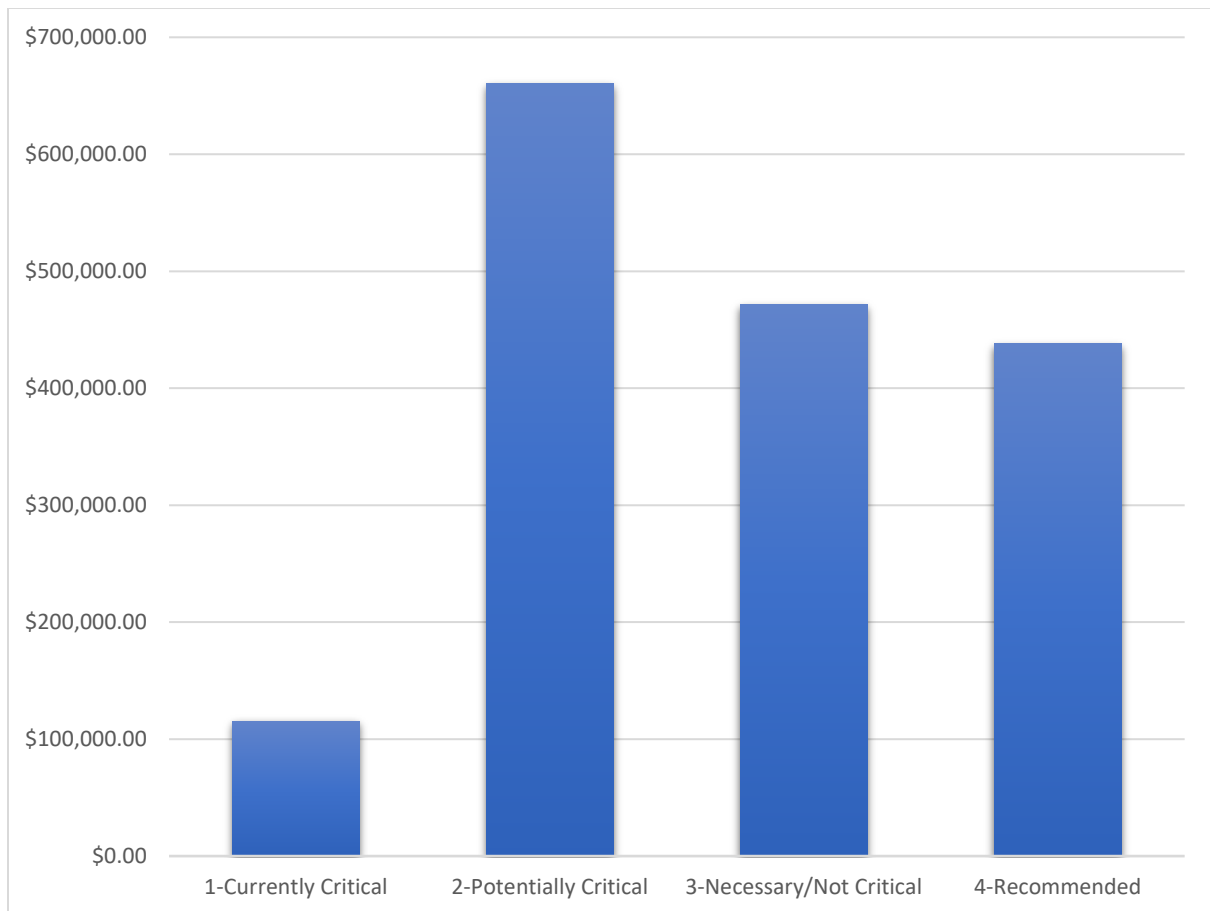
DISTRIBUTION OF NEEDS BY PRIORITY

CGL Facility Management has prioritized the identified work in order to assist with analyzing the deficiencies found during the assessment. The baseline prioritization model is not just based on replacement year or criticality but uses four key data attributes to build an overall importance metric for every recommendation: System type, the cause or nature of the issue, timing, and building mission incorporated into the model with relative weighting to provide an overall priority score. Priority categories are shown below:

Priority 1 Currently Critical:	Systems requiring immediate action that have failed, compromises staff or public safety, or required to be upgraded to comply with current codes and accessibility
Priority 2 Potentially Critical:	A system or component is nearing the end of useful life, if not addressed, will cause additional deterioration and added repair costs
Priority 3 Necessary / Not Critical:	Lifecycle replacements necessary but not critical or mid-term future replacements to maintain the integrity of the facility or component
Priority 4 Recommended:	Items under this classification are not required for normal function and operation of the facility but would improve the efficiency and functionality of the facility or reduce long-term maintenance.

The chart below illustrates the breakdown of expenditure according to the priority coding providing an opportunity to strategically plan and effectively direct funding to the highest priority.

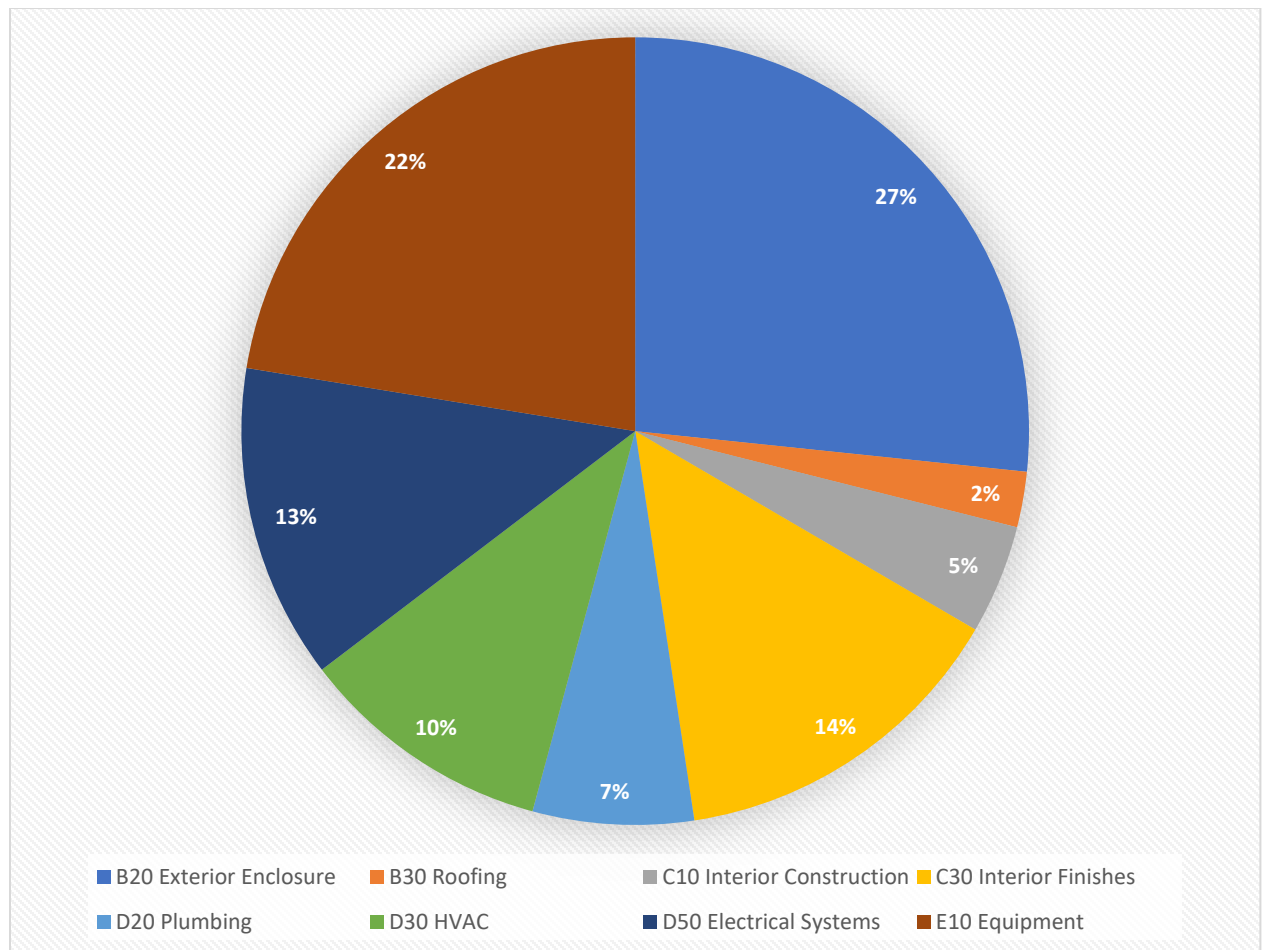
DISTRIBUTION OF IMMEDIATE NEEDS (YEAR 1) BY BUILDING SYSTEM

Building System	Estimated Cost	Percent of Total Cost
B20 Exterior Enclosure	\$199,139	26.65%
B30 Roofing	\$17,036	2.28%
C10 Interior Construction	\$33,467	4.48%
C30 Interior Finishes	\$106,056	14.19%
D20 Plumbing	\$49,352	6.60%
D30 HVAC	\$78,035	10.44%
D50 Electrical Systems	\$96,570	12.92%
E10 Equipment	\$167,655	22.43%

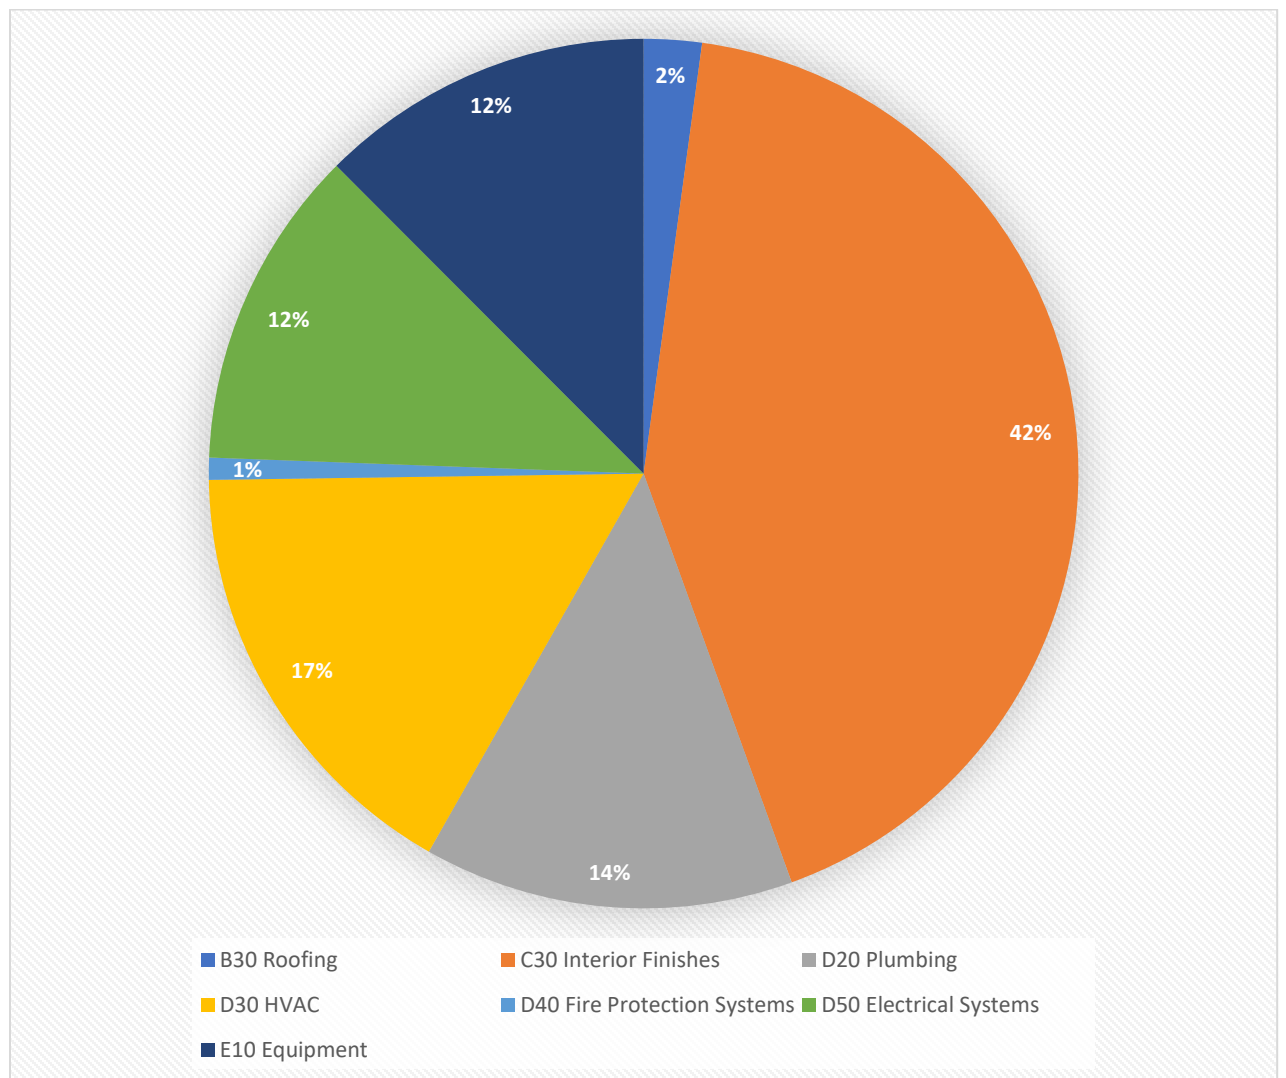
DISTRIBUTION OF FUTURE NEEDS (YEAR 2 TO YEAR 10) BY BUILDING SYSTEM

Building System	Estimated Cost	Percent of Total Cost
B30 Roofing	\$20,191.90	2.15%
C30 Interior Finishes	\$396,830.00	42.32%
D20 Plumbing	\$128,976.24	13.75%
D30 HVAC	\$155,175.80	16.55%
D40 Fire Protection Systems	\$7,682.50	0.82%
D50 Electrical Systems	\$111,860.16	11.93%
E10 Equipment	\$117,077.88	12.48%

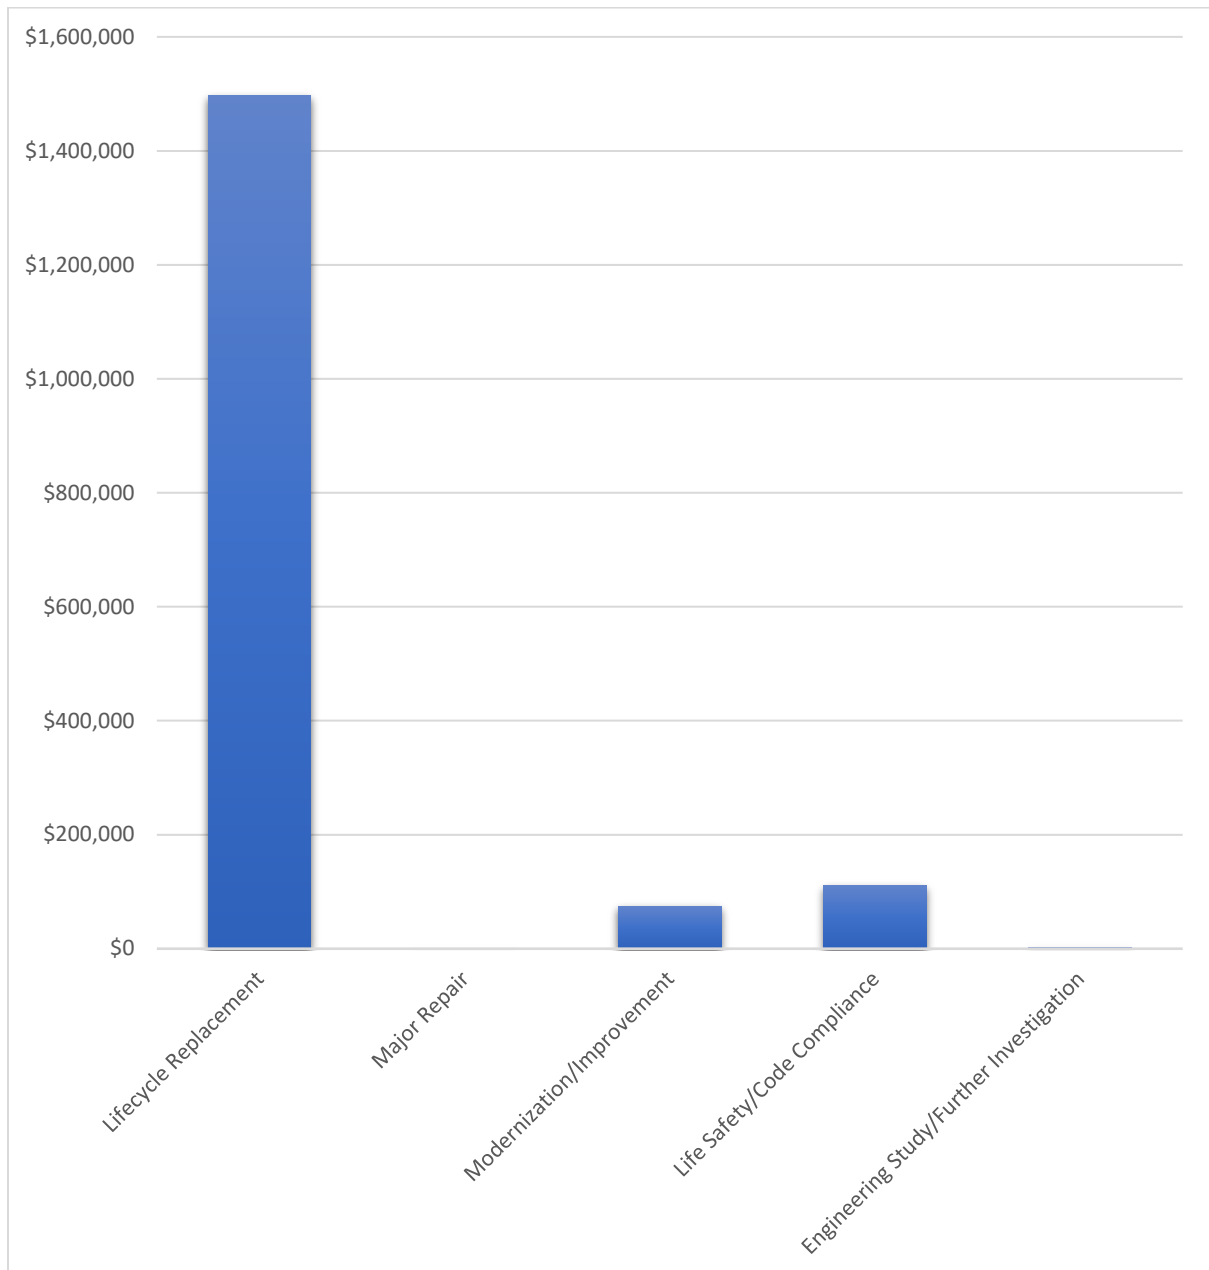
DISTRIBUTION OF NEEDS BY PLAN TYPE

PLAN TYPE	TOTAL COST
Lifecycle Replacement	\$1,496,834
Major Repair	\$430
Modernization/Improvement	\$74,751
Life Safety/Code Compliance	\$110,974
Engineering Study/Further Investigation	\$2,115
