Kansas Department of Corrections  
Norton Correctional Facility  
June 2022

## ASSESSMENT OVERVIEW

Norton Correctional Facility

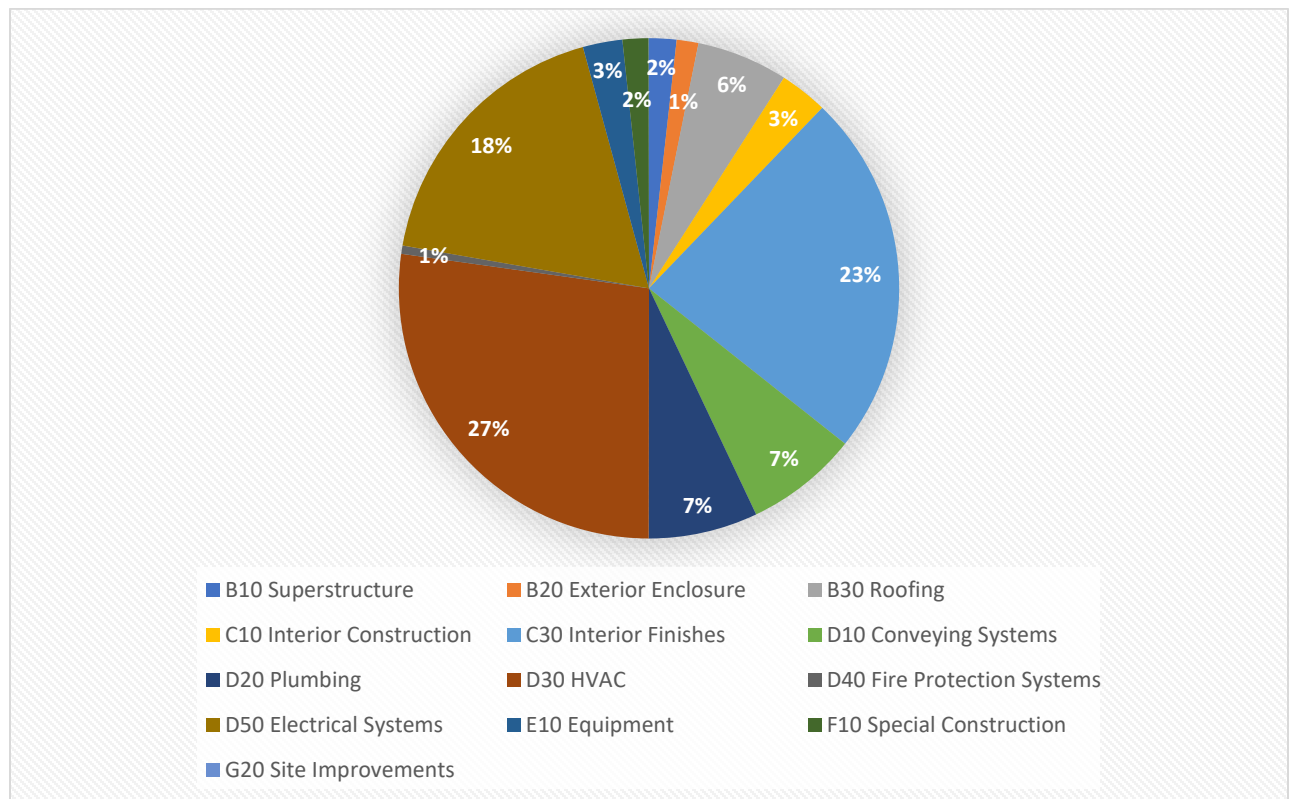
## DISTRIBUTION OF FUTURE NEEDS (YEAR 2 TO YEAR 10) BY BUILDING SYSTEM

Building System	Estimated Cost	Percent of Total Cost
B10 Superstructure	\$200,017.30	1.77%
B20 Exterior Enclosure	\$159,383.06	1.41%
B30 Roofing	\$667,404.00	5.90%
C10 Interior Construction	\$351,156.24	3.10%
C30 Interior Finishes	\$2,658,911.53	23.49%
D10 Conveying Systems	\$825,485.00	7.29%
D20 Plumbing	\$799,786.72	7.07%
D30 HVAC	\$3,077,144.44	27.18%
D40 Fire Protection Systems	\$60,535.00	0.53%
D50 Electrical Systems	\$2,038,043.16	18.00%
E10 Equipment	\$289,221.86	2.56%
F10 Special Construction	\$190,260.00	1.68%
G20 Site Improvements	\$2,120.00	0.02%
