Kansas Department of Corrections
Topeka Correctional Facility West
June 2022

ASSESSMENT OVERVIEW

Topeka Correctional Facility West

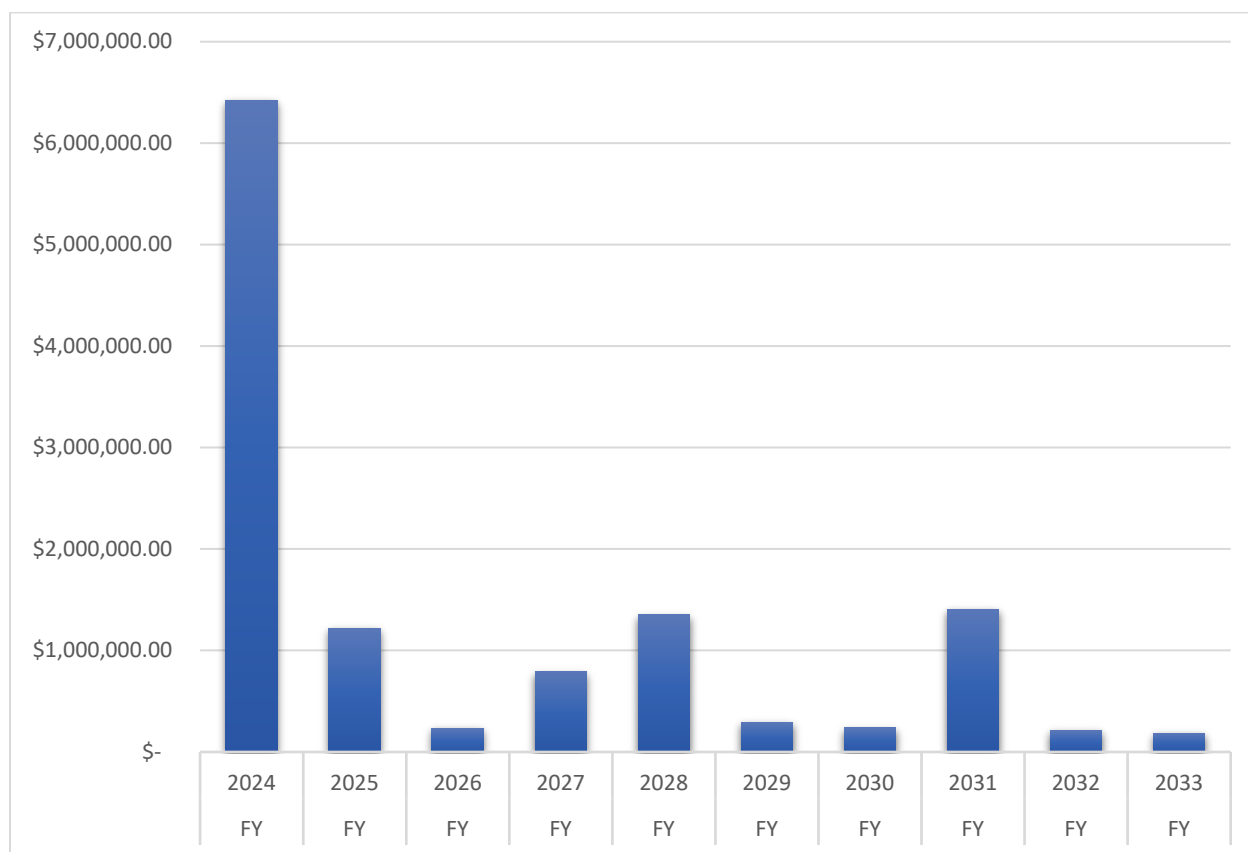
The building expenditure summary section provides an executive overview of the findings from the assessment. The chart below provides a summary of anticipated yearly expenditures over the study period for the Topeka Correctional Facility West. Further details of these expenditures are included within each respective report section and within the expenditure forecast in Appendix A of this report. The results illustrate a total anticipated expenditure over the study period of approximately:

\$12,359,430

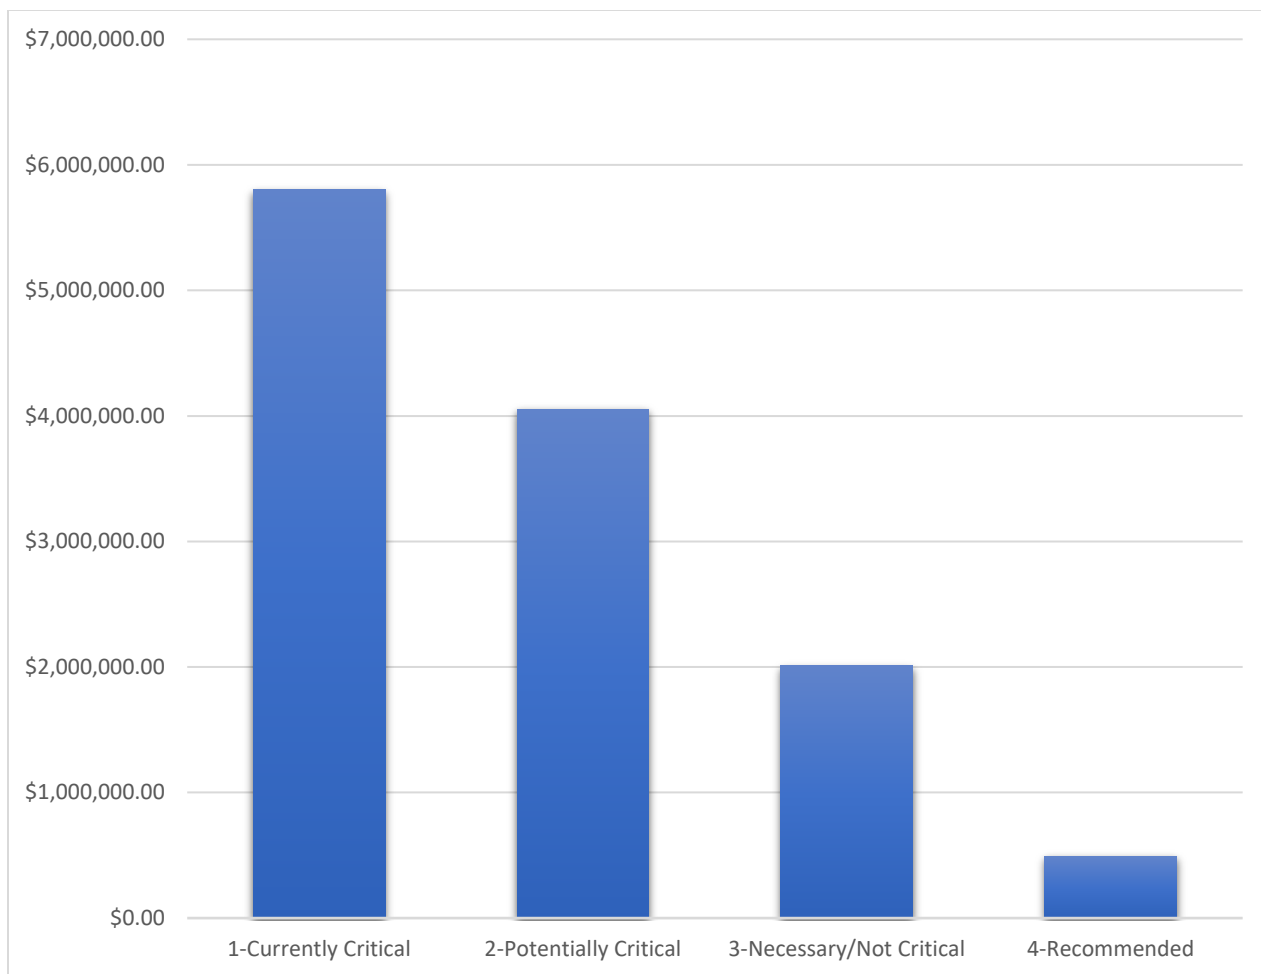
DISTRIBUTION OF NEEDS BY PRIORITY

The chart below illustrates the breakdown of expenditure according to the priority coding providing an opportunity to strategically plan and effectively direct funding to the highest priority.

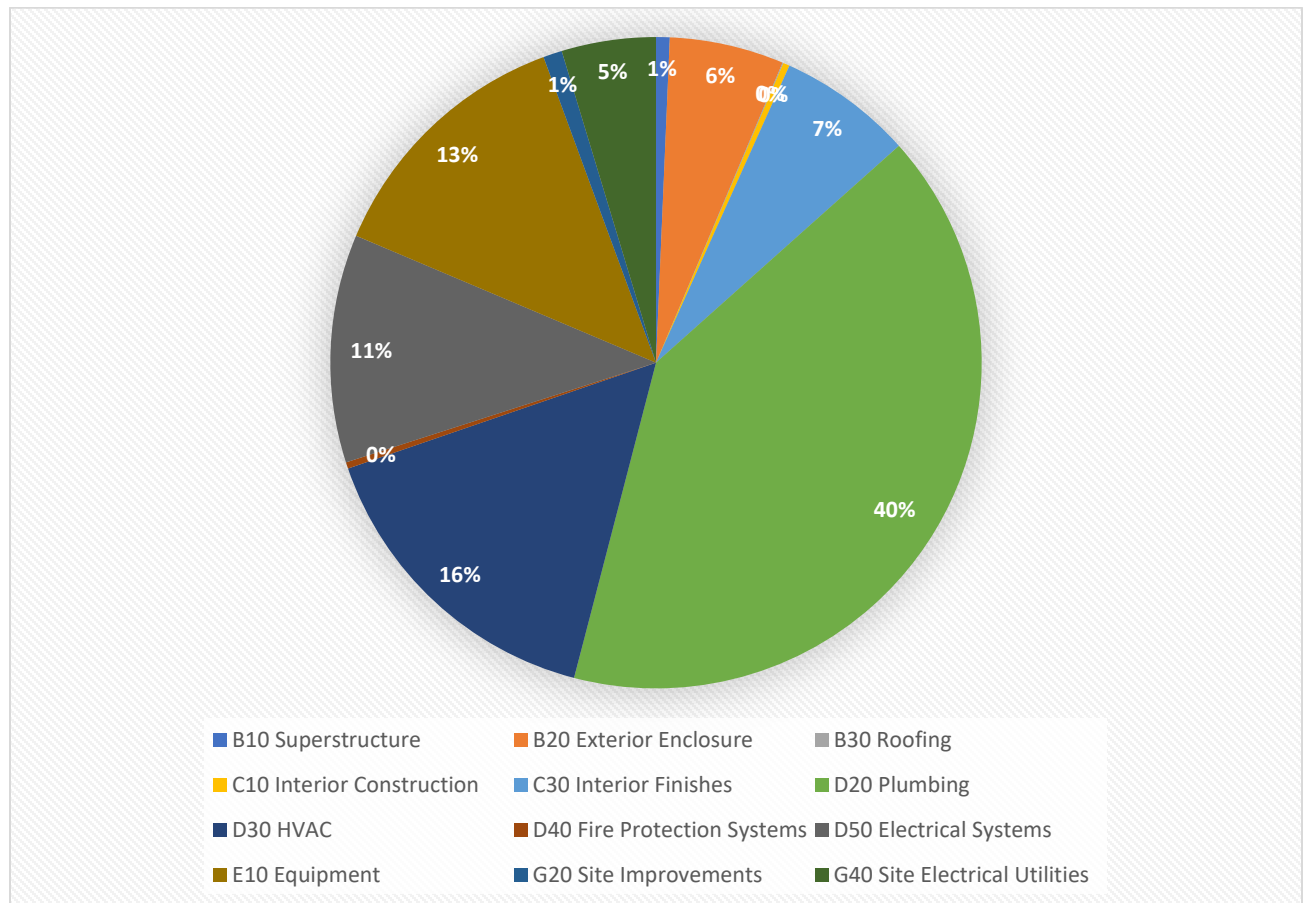
DISTRIBUTION OF IMMEDIATE NEEDS (YEAR 1) BY BUILDING SYSTEM

Building System	Estimated Cost	Percent of Total Cost
B10 Superstructure	\$43,461	0.68%
B20 Exterior Enclosure	\$364,617	5.68%
B30 Roofing	\$3,012	0.05%
C10 Interior Construction	\$20,404	0.32%
C30 Interior Finishes	\$429,116	6.68%
D20 Plumbing	\$2,610,975	40.65%
D30 HVAC	\$1,007,209	15.68%
D40 Fire Protection Systems	\$20,395	0.32%
D50 Electrical Systems	\$727,315	11.32%
E10 Equipment	\$835,917	13.01%
G20 Site Improvements	\$60,130	0.94%
G40 Site Electrical Utilities	\$300,300	4.68%

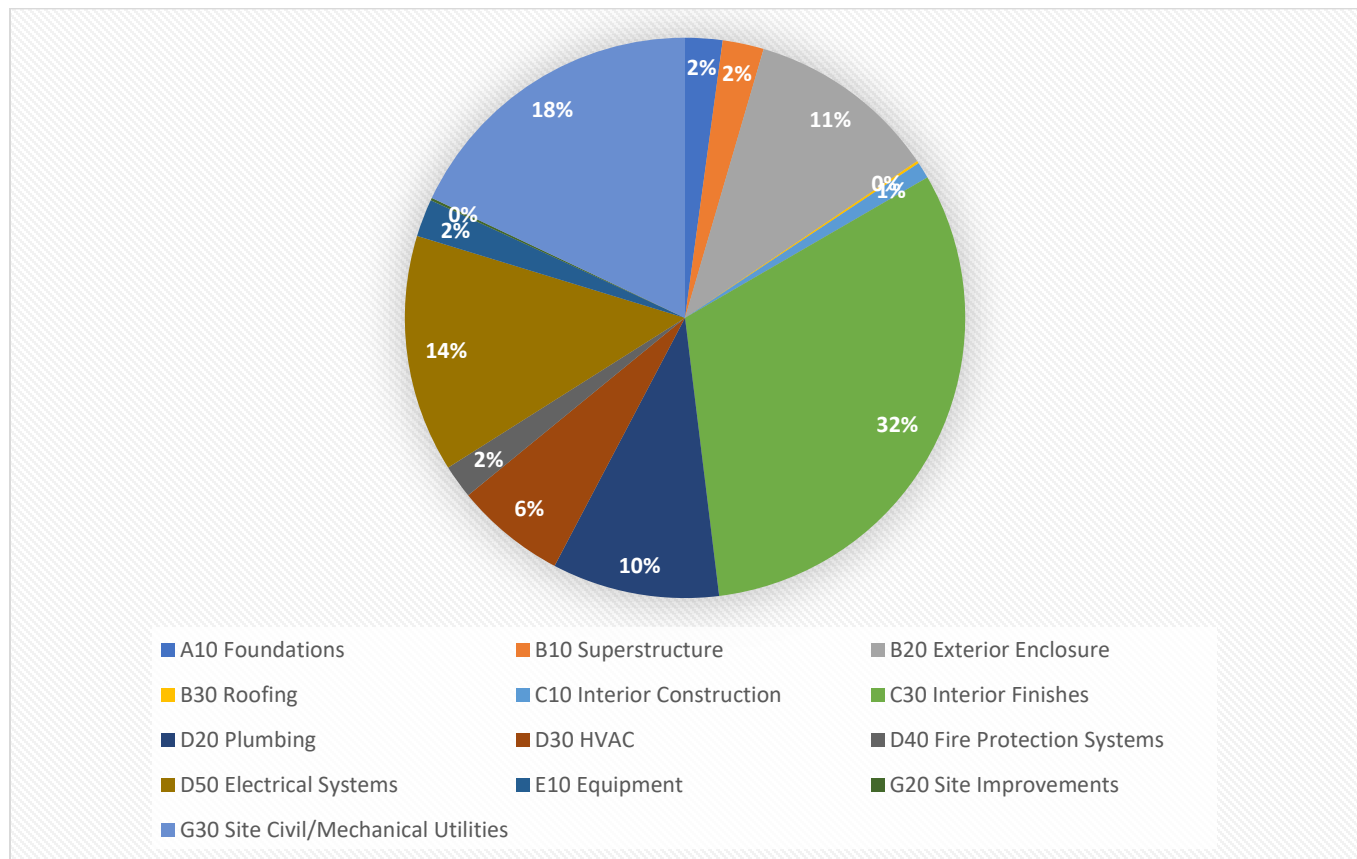
DISTRIBUTION OF FUTURE NEEDS (YEAR 2 TO YEAR 10) BY BUILDING SYSTEM

Building System	Estimated Cost	Percent of Total Cost
A10 Foundations	\$127,825.60	2.15%
B10 Superstructure	\$141,129.52	2.38%
B20 Exterior Enclosure	\$654,028.84	11.02%
B30 Roofing	\$8,542.56	0.14%
C10 Interior Construction	\$56,312.80	0.95%
C30 Interior Finishes	\$1,864,904.22	31.41%
D20 Plumbing	\$573,078.62	9.65%
D30 HVAC	\$378,828.00	6.38%
D40 Fire Protection Systems	\$115,205.72	1.94%
D50 Electrical Systems	\$813,102.28	13.70%
E10 Equipment	\$128,964.36	2.17%
G20 Site Improvements	\$8,727.18	0.15%
G30 Site Civil/Mechanical Utilities	\$1,065,930.00	17.96%

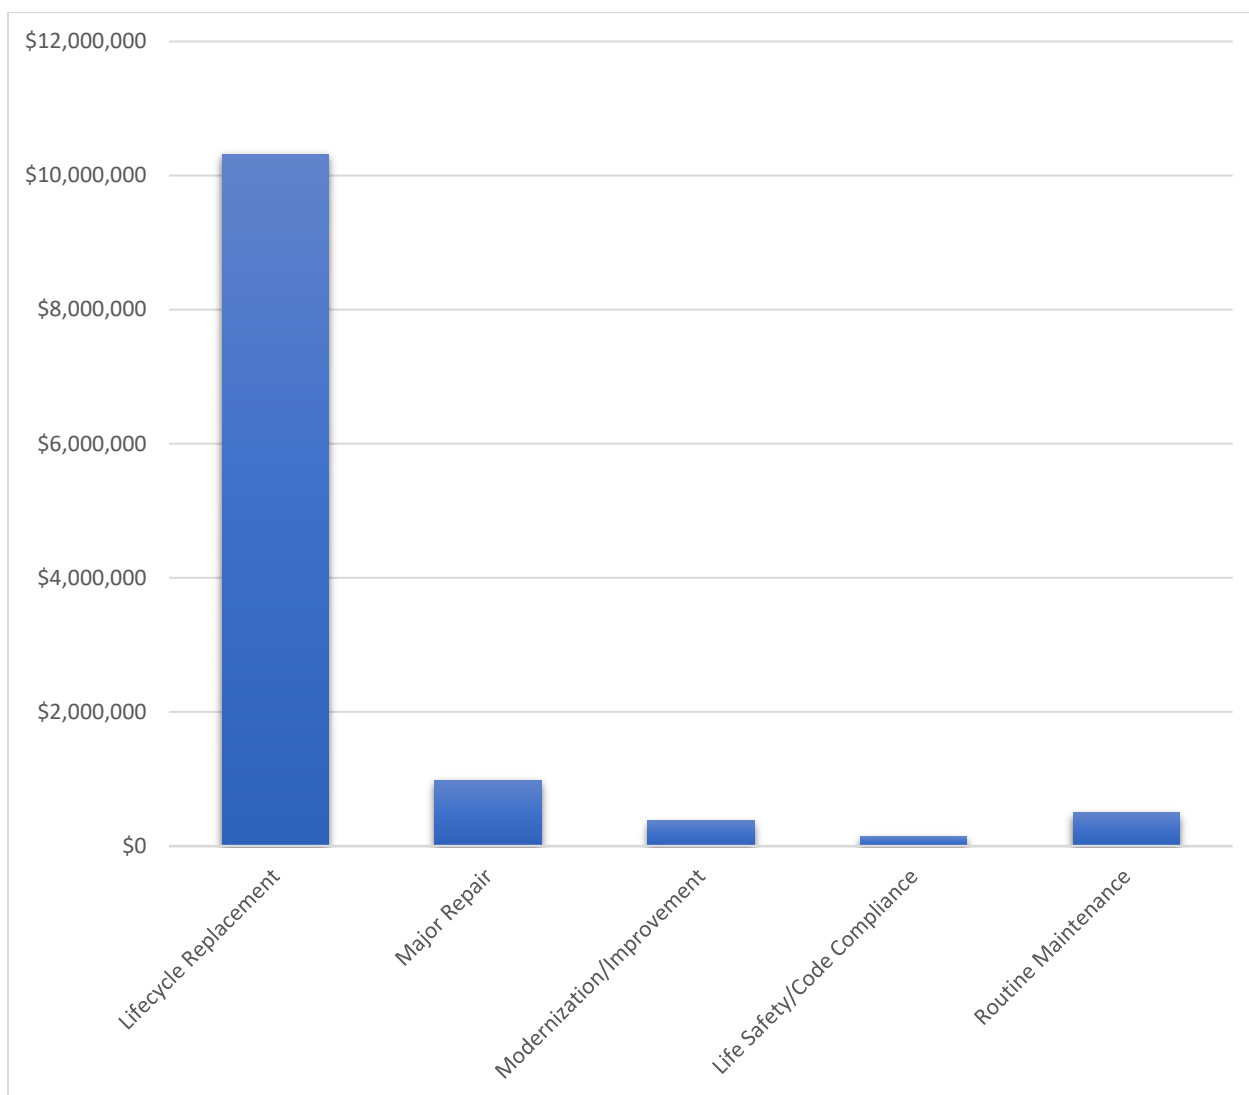
DISTRIBUTION OF NEEDS BY PLAN TYPE

PLAN TYPE	TOTAL COST
Lifecycle Replacement	\$10,319,396
Major Repair	\$981,792
Modernization/Improvement	\$375,248
Life Safety/Code Compliance	\$141,208
Routine Maintenance	\$494,434
